Accelerated Low Water Corrosion (ALWC)

Professional Diving Services

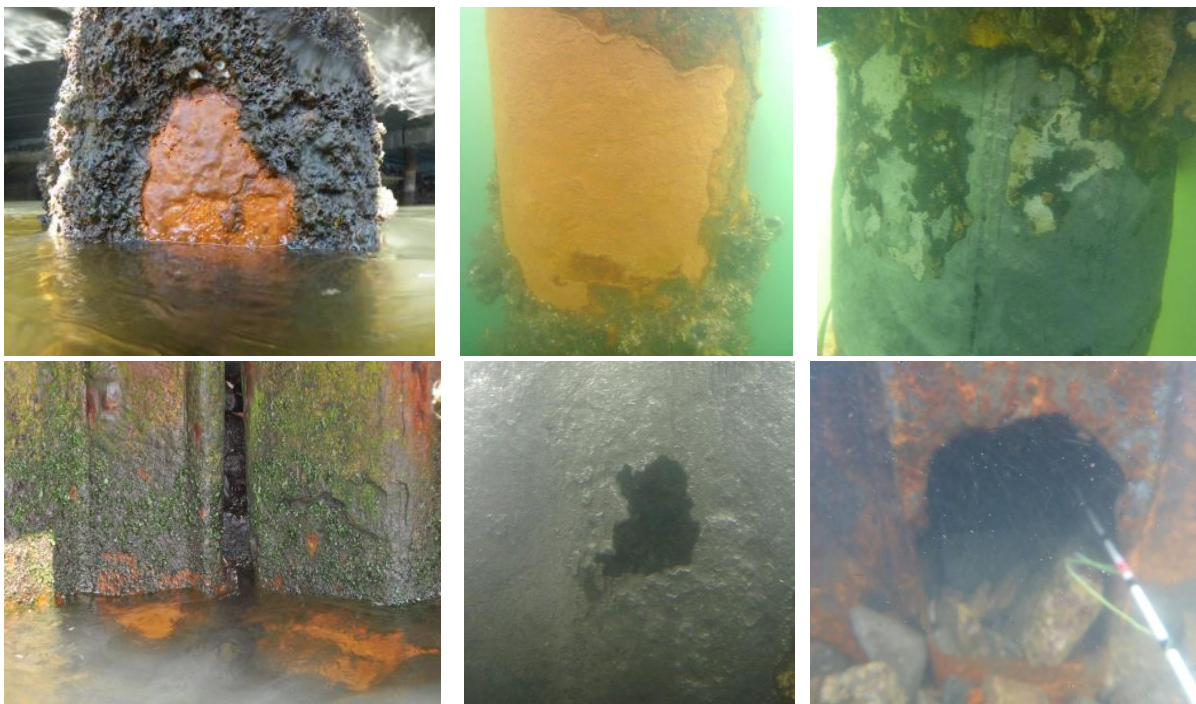
Signs and damage from ALWC

Hallmark signs of ALWC include the formation of a bright orange surface layer that is often lightly adhered.

Prior to 2013, marine structures in Australia were not designed or built to allow for such aggressive attack. Without intervention many structures have resulted in loss of structural steel on key elements such as pier piles and wharf retaining wall.

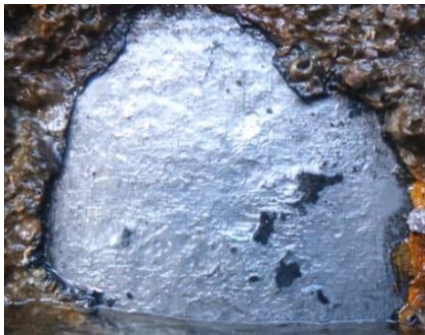
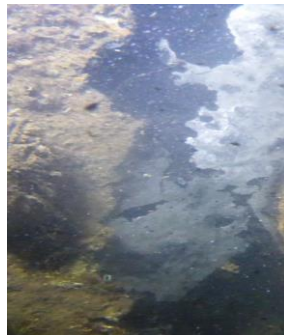
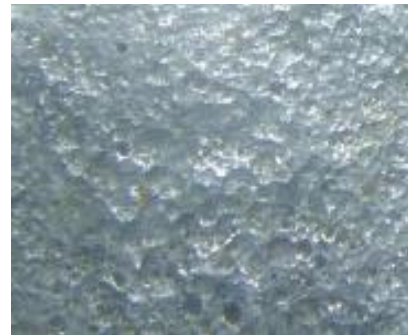
Surfaces commonly underneath orange blooms

ALWC on steel piles and sheet piling is assessed by visual inspection, cleaning and steel thickness testing by professional divers and engineers. Other key signs of ALWC are the presence of an underlying black layer and pitted steel surfaces.

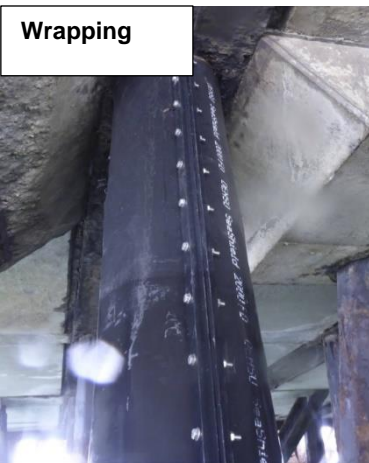
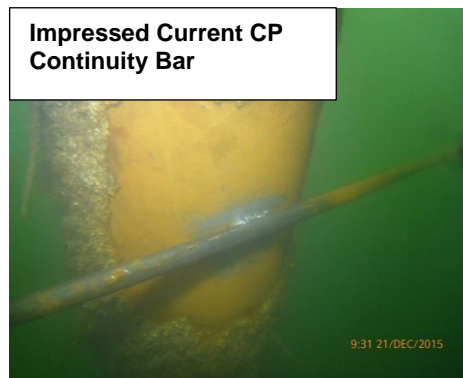
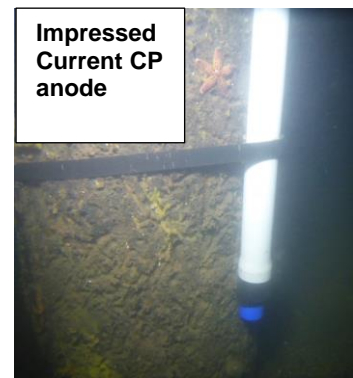
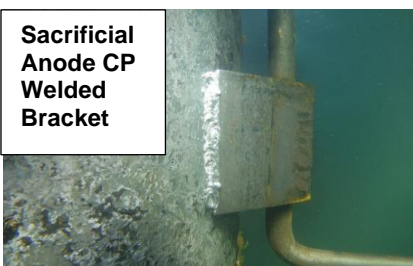
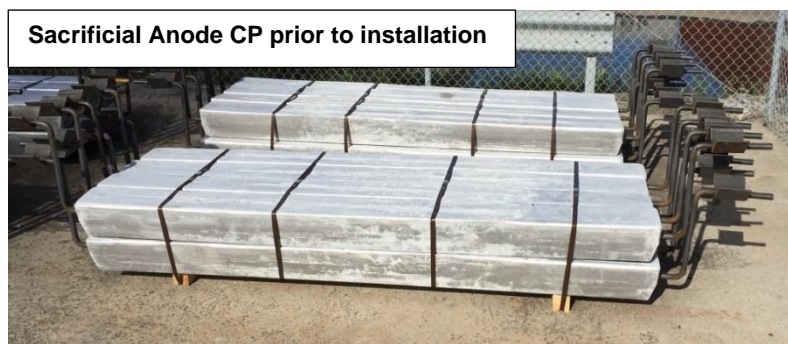
Treatment

Protection of new and existing structures commonly includes cathodic protection and barrier wrapping. Strengthening treatments commonly include plate patch welding or encasements.
